Manhole Inspection Summary

Manhole # S19I1_004MH

Insp Date: **4/18/08 10:17 AM**

Location Address: **3040 janice av**

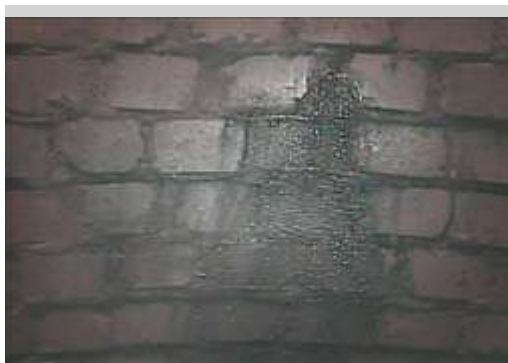
Defect 4

Infiltration: ☐ None ☐ Joint ☐ Cracks ☐ Mortar ☐ Roots ☒ **Wall**

infiltration @ barrel wall

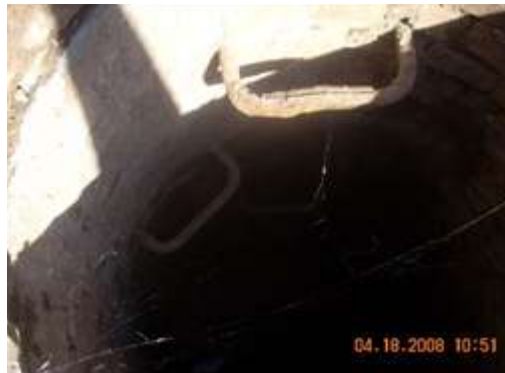
Defect 3

Steps Count: **7** Missing: **0** ☒ **Corroded**

corroded steps

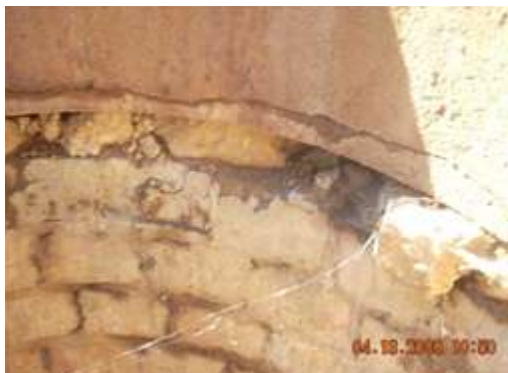
Defect 2

Condition: ☐ Sound ☐ Cracked ☐ Root Intrusion ☐ Loose Brick ☒ **Deteriorated**

deteriorated chimney

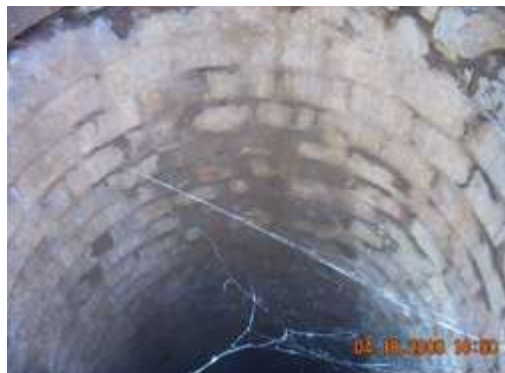
Defect 1

Infiltration: ☐ None ☐ Joint ☐ Cracks ☐ Mortar ☐ Roots ☒ **Wall**

infiltration @ corbel wall

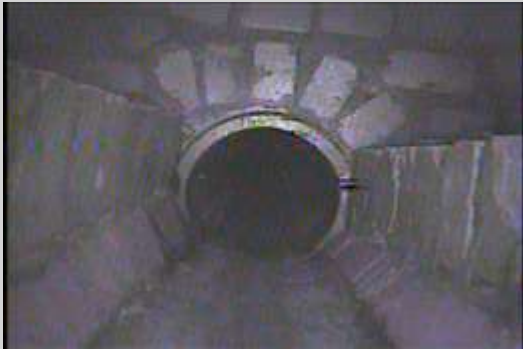
12 O'Clock Outflow

8 in. Circular Gravity Sewer
Pipe Out @ 12 O'Clock

Pipe Height: **8.4** (in.) Rod and Bar (Angled)
Pipe Material: **Clay** ☐ Pipe Lined
Invert Depth: **12.63** (ft.) Flow Characteristics: **Slow**
Deposits: ☒ None ☐ Mud ☐ Sludge ☐ Debris ☐ Grease
Silt Depth: **0** (in.) Deposits Extent:
Infiltration: **None** Pipe Seal Cond: **Sound**

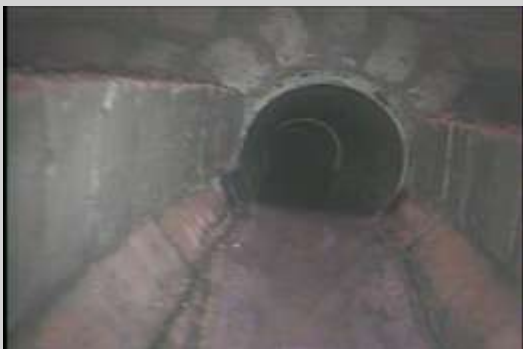
6 O'Clock Inflow

8 in. Circular Gravity Sewer
Pipe In @ 6 O'Clock

Pipe Height: **8.4** (in.) Rod and Bar (Angled)
Pipe Material: **Clay** ☐ Pipe Lined
Invert Depth: **12.25** (ft.) Flow Characteristics: **Slow**
Deposits: ☒ None ☐ Mud ☐ Sludge ☐ Debris ☐ Grease
Silt Depth: **0** (in.) Deposits Extent:
Infiltration: **None** Pipe Seal Cond: **Sound**
